Attachment 5
Photograph Log

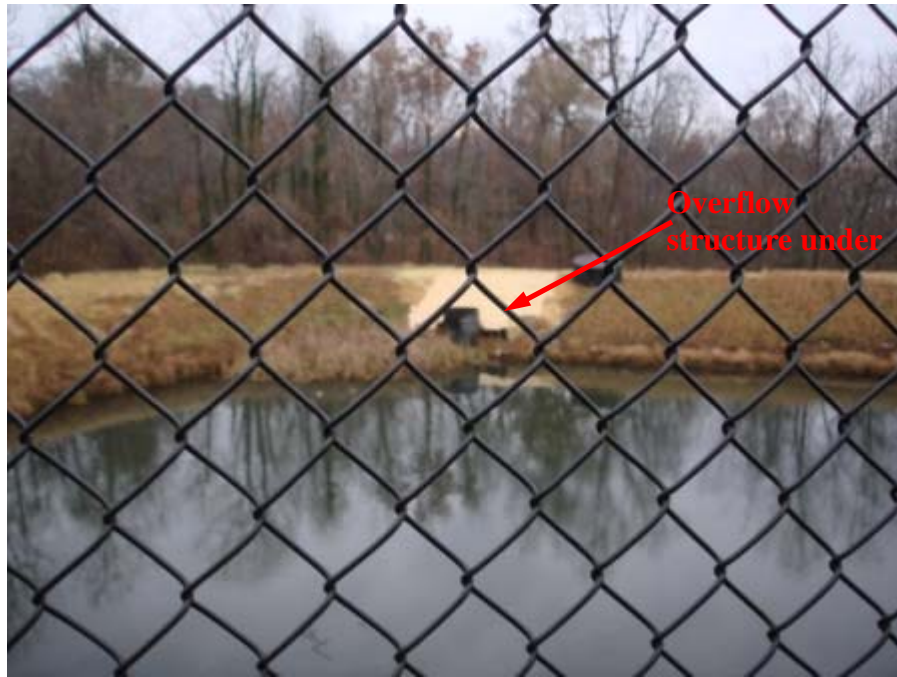
Photograph 1. Riva Festival –Stormwater Pond (facing outfall structure repair site)

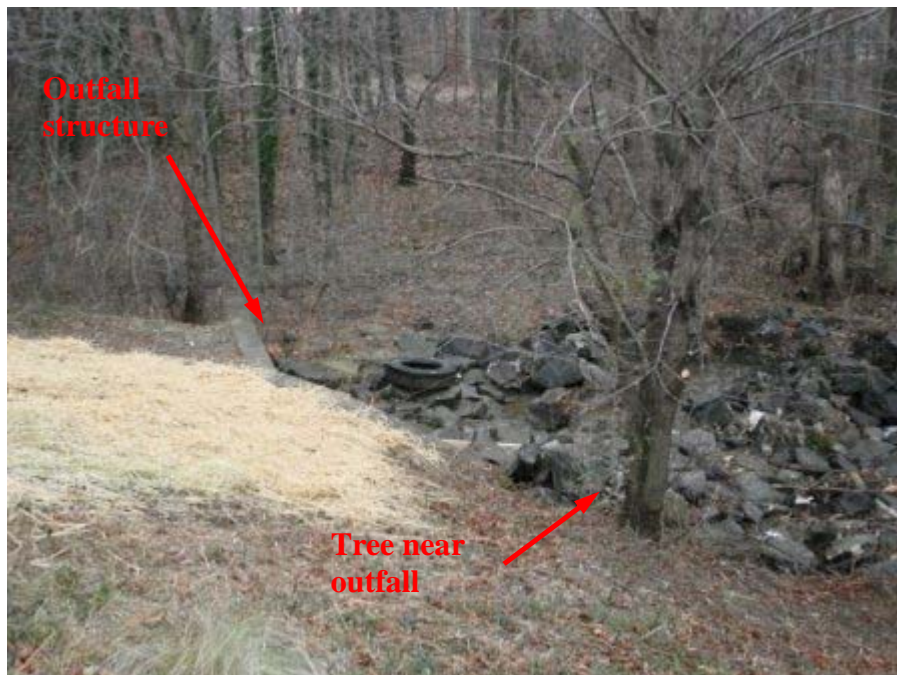
Photograph 2. Riva Festival –Downstream of Stormwater Pond (outfall structure)

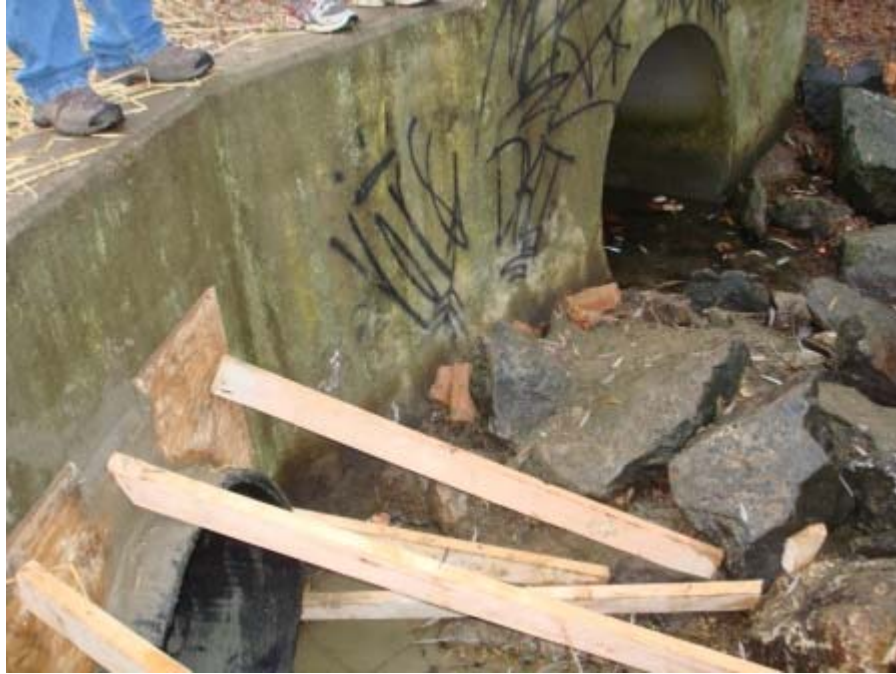
Photograph 3. Riva Festival – Downstream of Stormwater Pond (outfall structure repair)

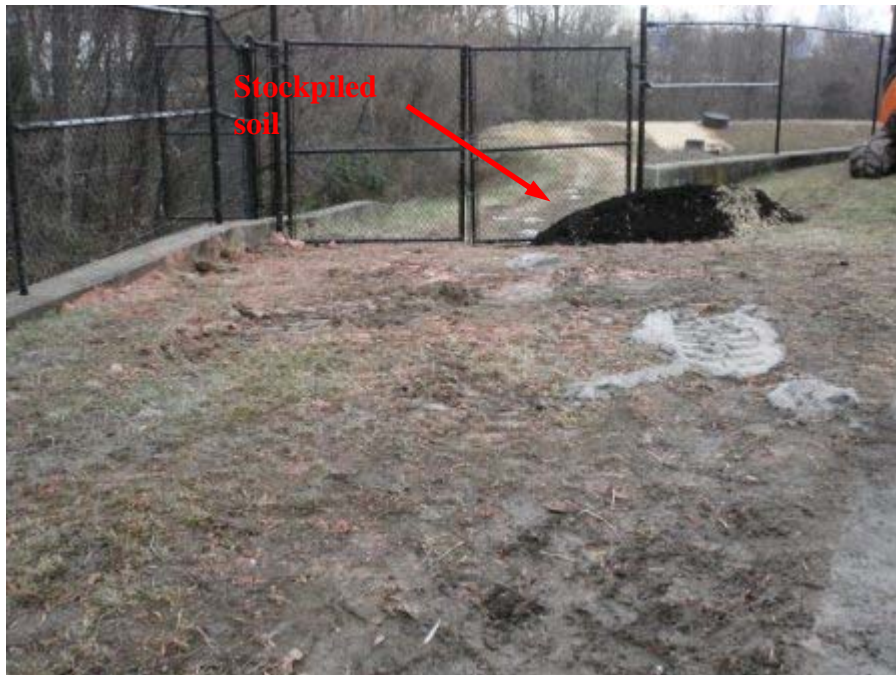
Photograph 4. Riva Festival – Stockpiled soil upstream of stormwater pond

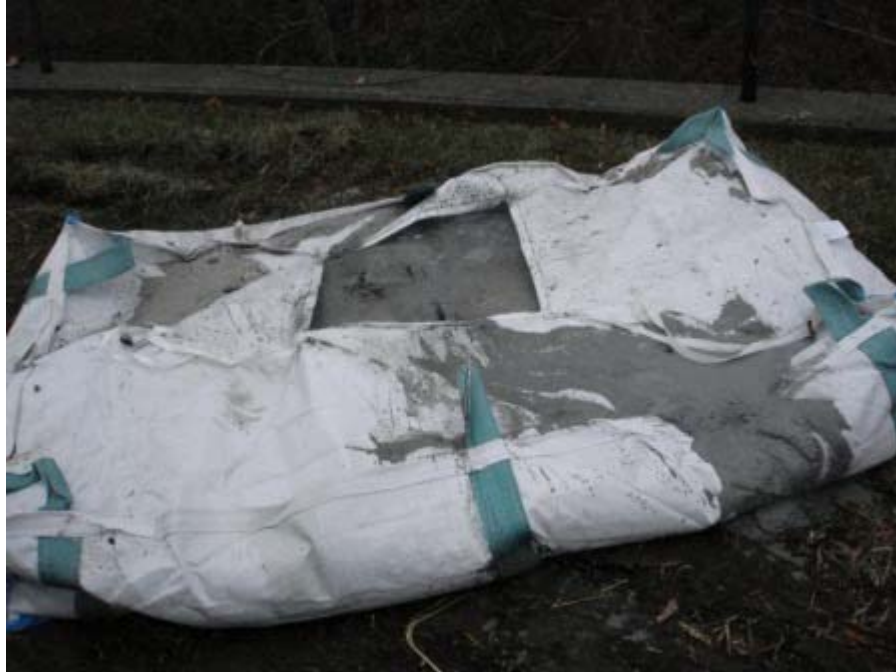
Photograph 5. Riva Festival – Stockpiled bag of flowable fill upstream of stormwater pond

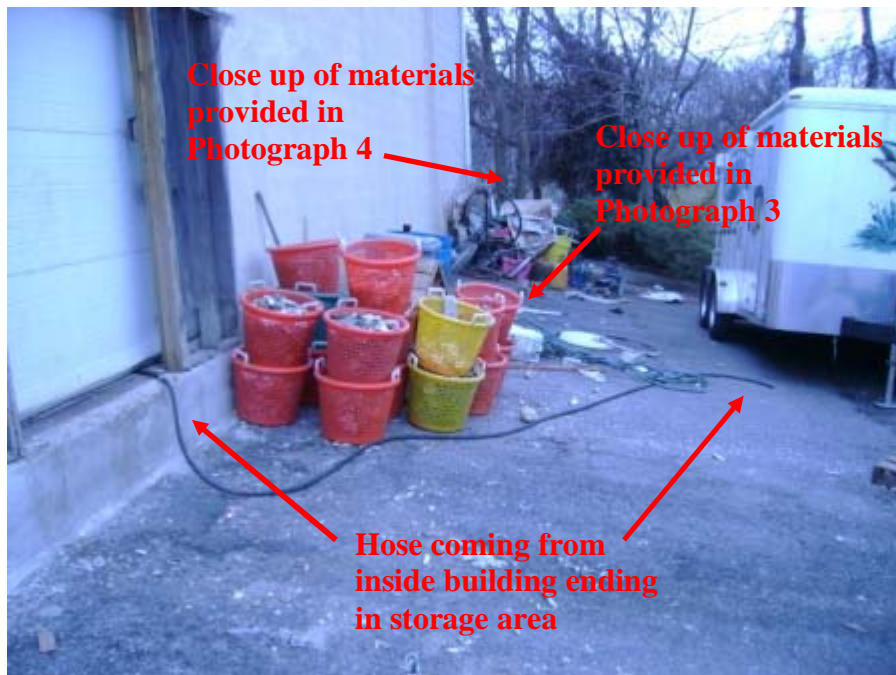
Photograph 16. Shoreline Seafood – Illicit Discharge Site Visit
View of a hose coming from inside the facility and draining to area behind the facility and of general housekeeping and materials storage behind the facility. Area is approximately 30 feet from storm drain.

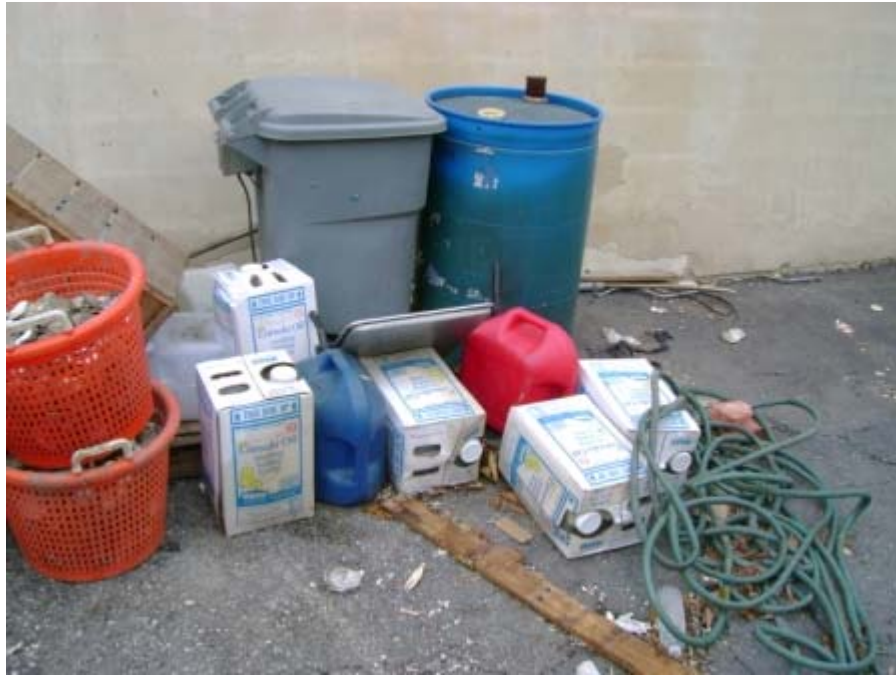
Photograph 17. Shoreline Seafood – Illicit Discharge Site Visit

Close up view of materials stored behind facility and exposed to stormwater from Photograph 2. Materials include oyster shells, full and empty containers of canola oil and full container of gasoline.

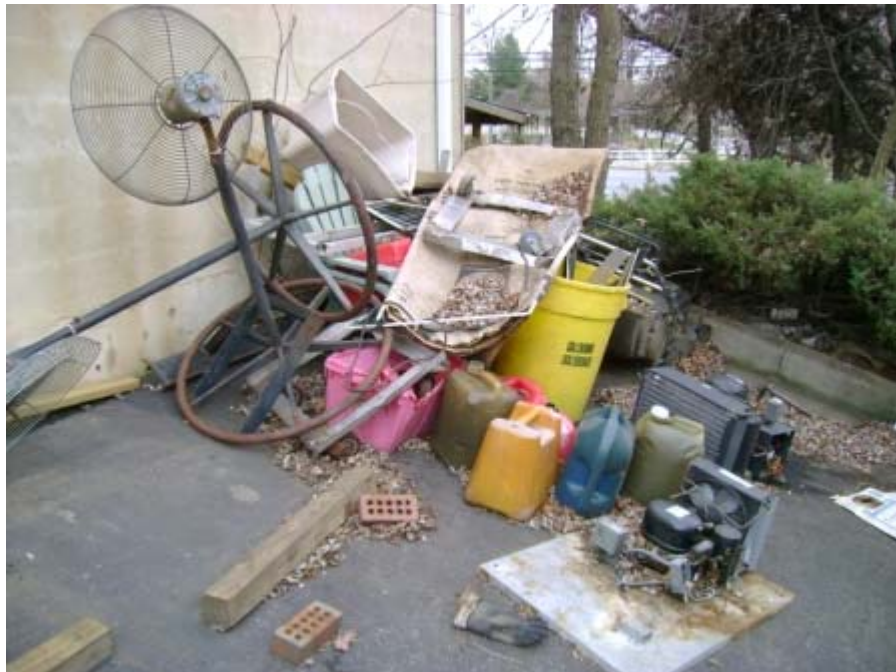
Photograph 18. Shoreline Seafood – Illicit Discharge Site Visit

Close up view of materials stored behind facility and exposed to stormwater from Photograph 2. Materials include full container of canola oil, and miscellaneous debris.

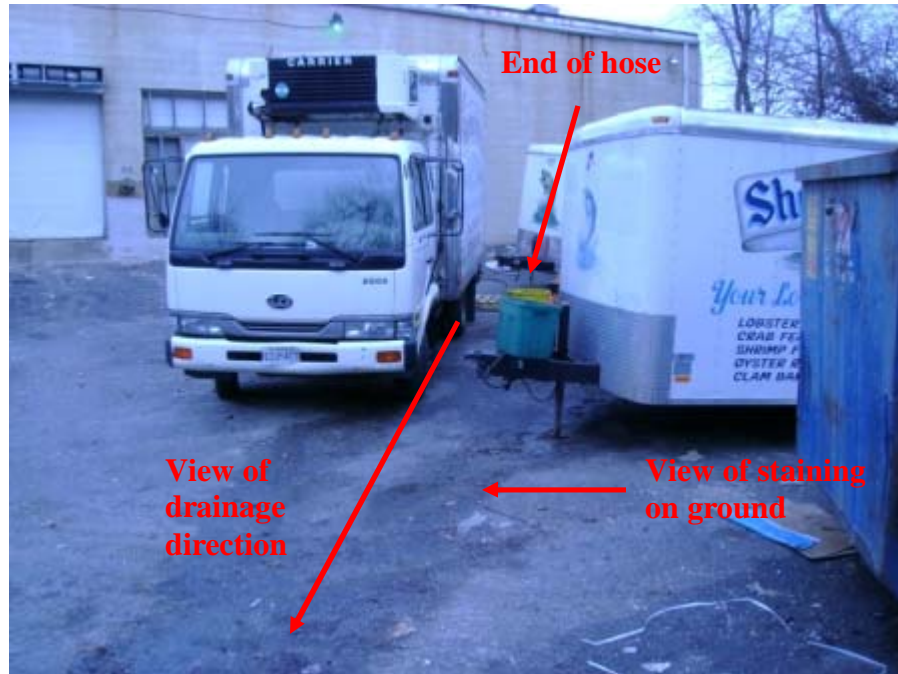
Photograph 19. Shoreline Seafood – Illicit Discharge Site Visit
View of area down grade from material storage areas in Photographs 2 through 4 and staining on ground.

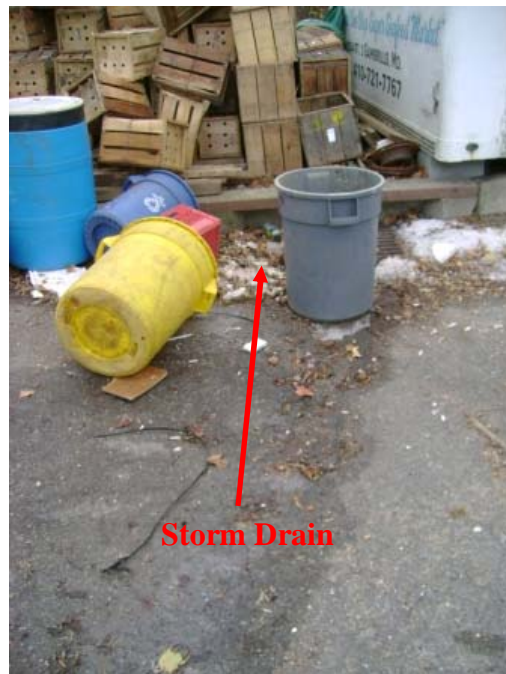
Photograph 20. Shoreline Seafood – Illicit Discharge Site Visit
View of storm drain in area with ice, debris and miscellaneous containers scattered near drain.

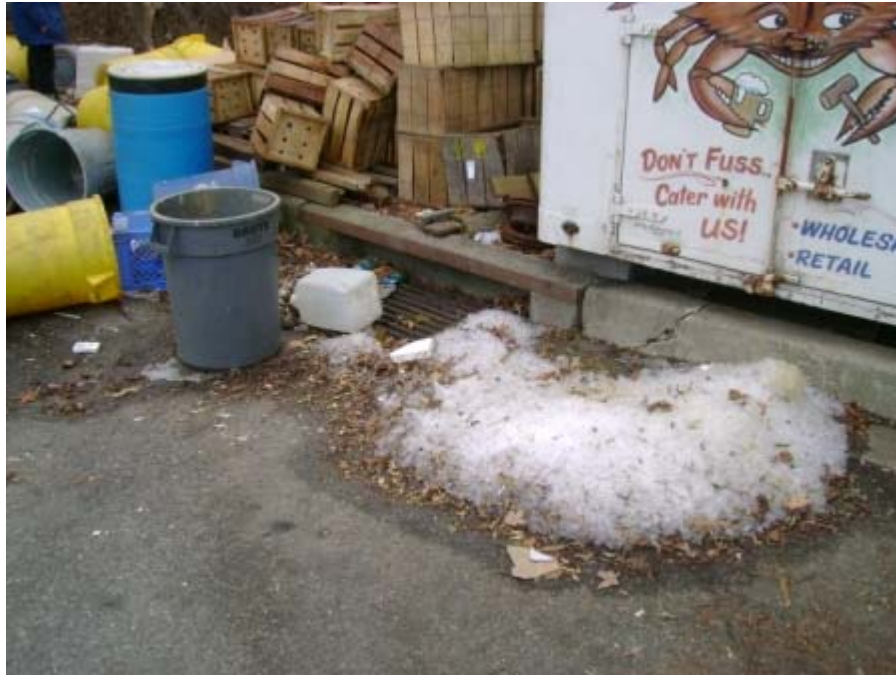
Photograph 21. Shoreline Seafood – Illicit Discharge Site Visit
Another view of storm drain in area with ice, debris and miscellaneous containers scattered near drain.

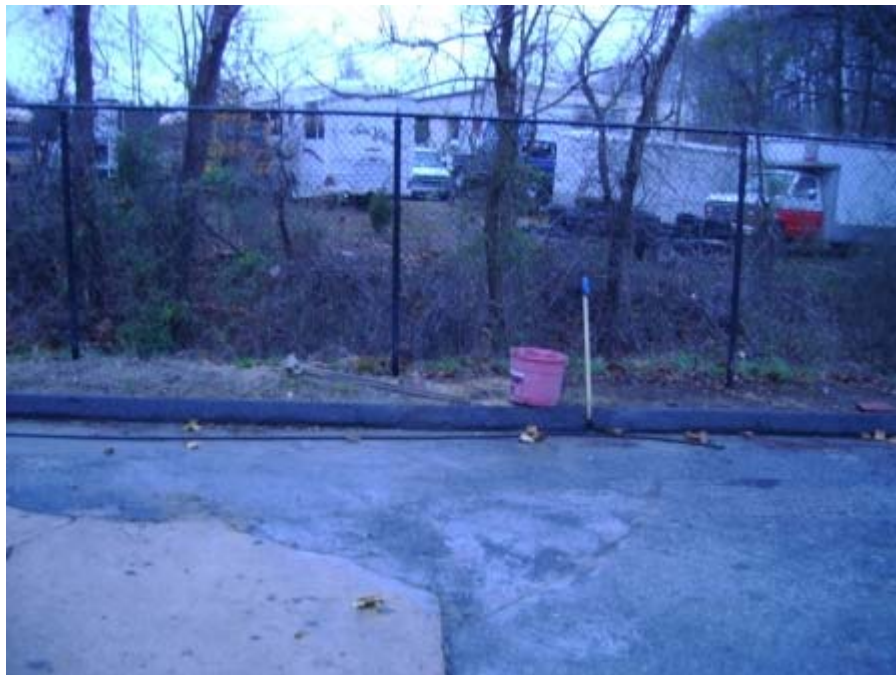
Photograph 30. Central District Roads – Crownsville Yard – County Properties
View of vehicle/equipment wash area on south side of the facility. (NOTE: Area drains toward storm water management pond)

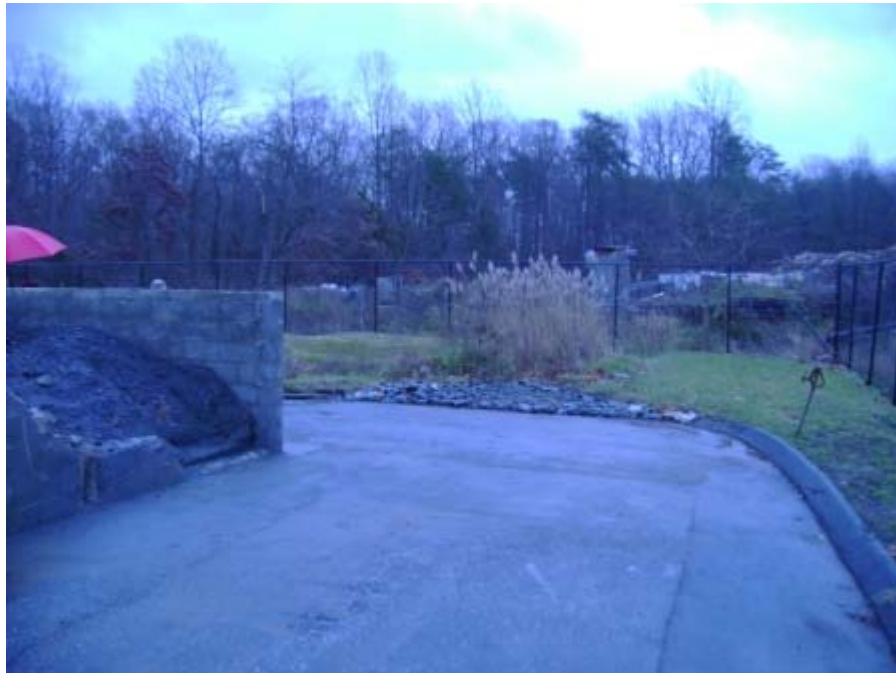
Photograph 32. Central District Roads – Crownsville Yard – County Properties
View of the milling material storage bin containing “milling” and a gravel inlet to the storm water management pond. The material storage bin is damaged and storm water is allowing milling to migrate and cover the gravel inlet to the pond.

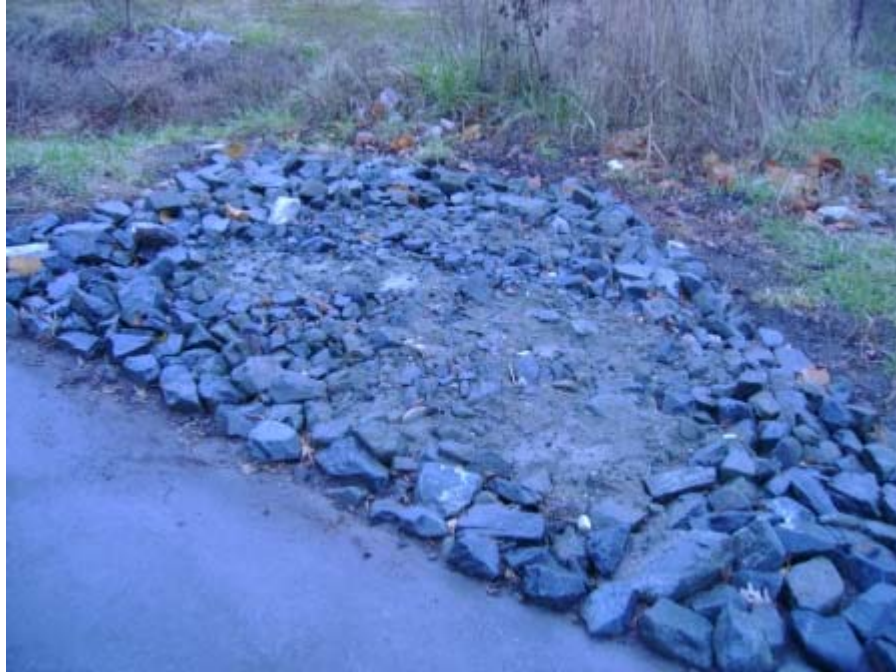
Photograph 33. Central District Roads – Crownsville Yard – County Properties
View of sediment in gravel inlet (noted in Photo 18) to storm water management pond.

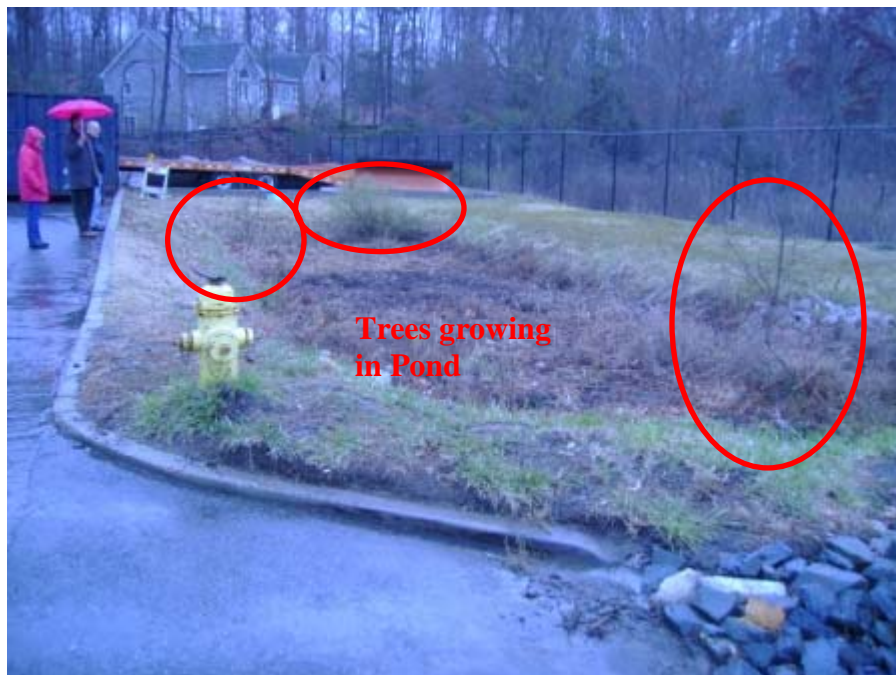
Photograph 34. Central District Roads – Crownsville Yard – County Properties
View of storm water management pond in apparent need of maintenance (NOTE: Several trees growing in pond).

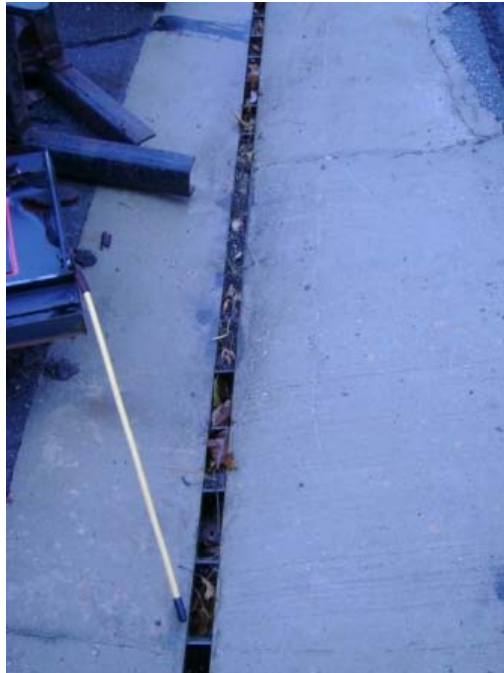
Photograph 36. Central District Roads – Crownsville Yard – County Properties
View of trench drain in north portion of the eastern border of the facility filled with sediment and debris. The drain is connected to the inlet identified in Photographs 21 and 23.

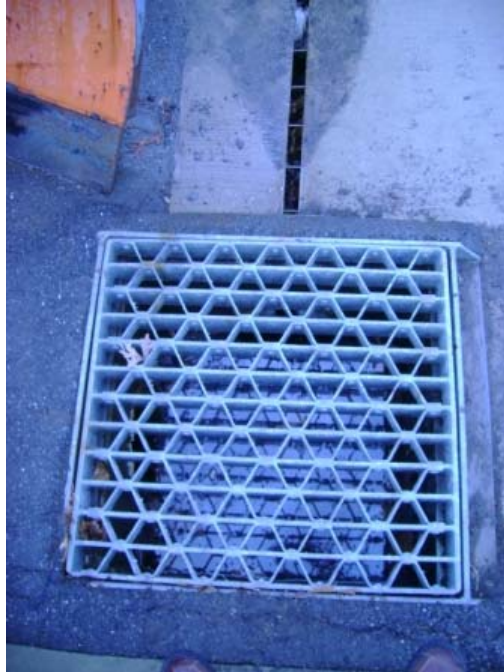
Photograph 37. Central District Roads – Crownsville Yard – County Properties
View of standing water in the storm water inlet mentioned in Photographs 21 and 21.

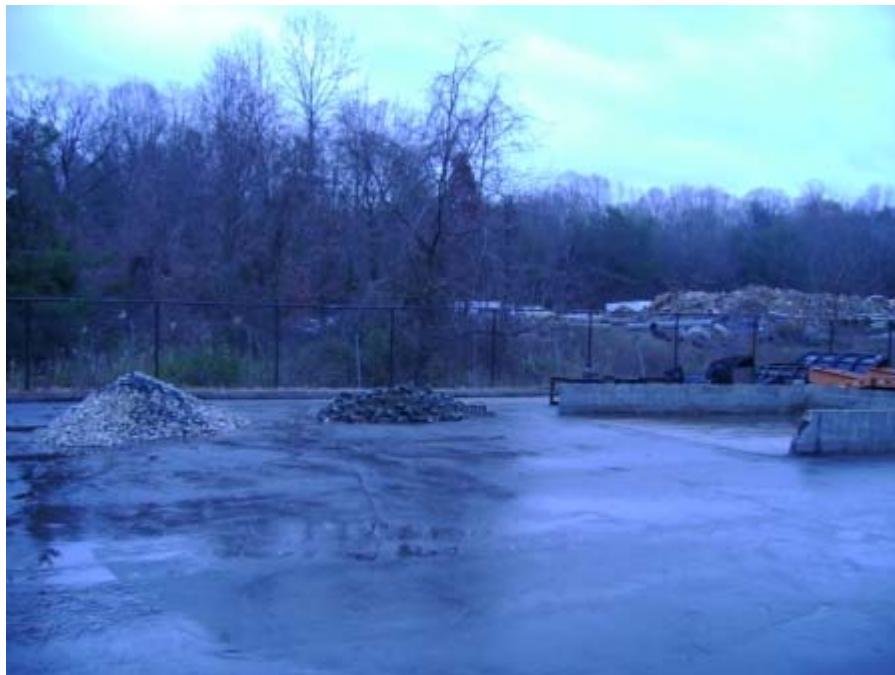
Photograph 38. Central District Roads – Crownsville Yard – County Properties
View of additional roadway material storage area, with uncovered stockpiles, graded toward the trench drain in Photographs 21 and 21.

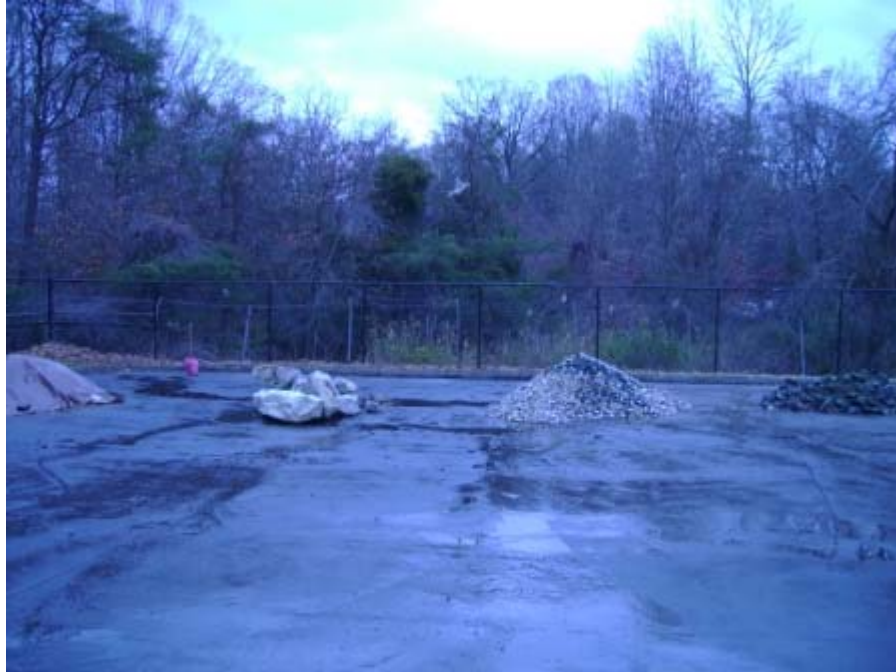
Photograph 39. Central District Roads – Crownsville Yard – County Properties
Another view of additional roadway material storage area, with uncovered stockpiles (same stockpiles as Photograph 24), graded toward the trench drain in Photographs 21 and 21.

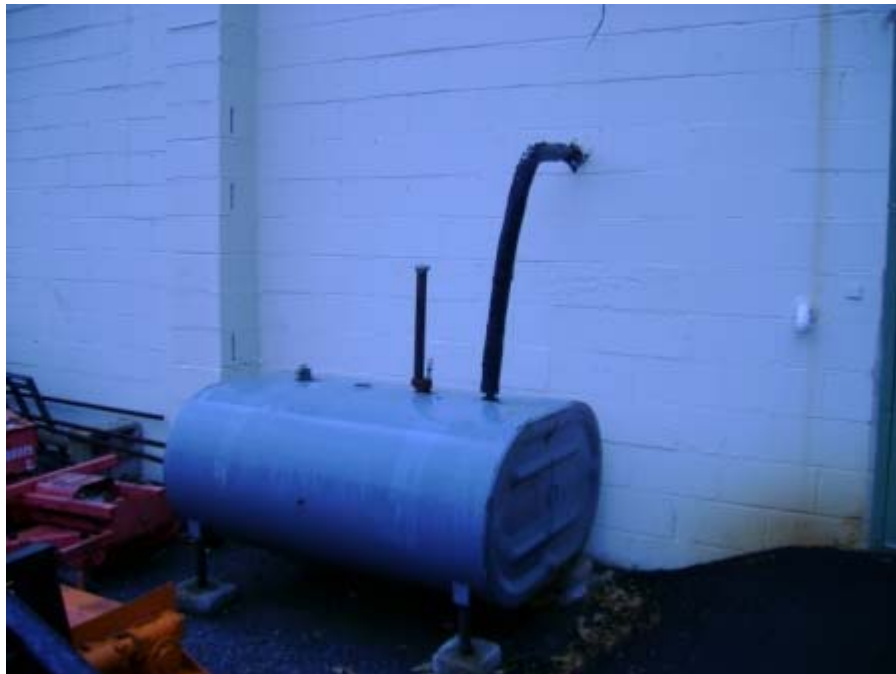
Photograph 40. Central District Roads – Crownsville Yard – County Properties
View of heating oil storage tank used for heating the maintenance bay without secondary containment.

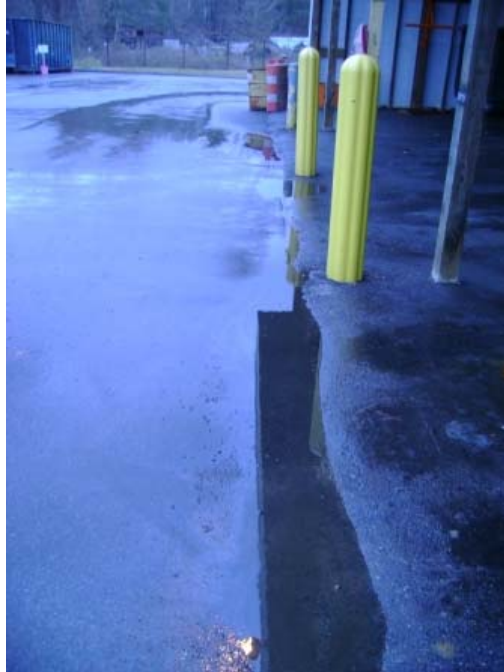
Photograph 41. Central District Roads – Crownsville Yard – County Properties
View of a sheen on storm water located outside covered vehicle/equipment storage area.

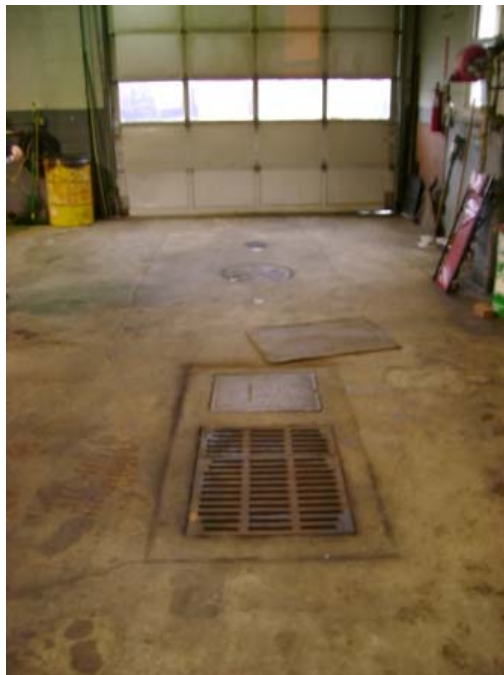
Photograph 42. Central District Roads – Crownsville Yard – County Properties
View of floor drain inside maintenance bay without oil/water separator. Drain is connected to underground storage tank (Photograph 29) located just outside maintenance building.

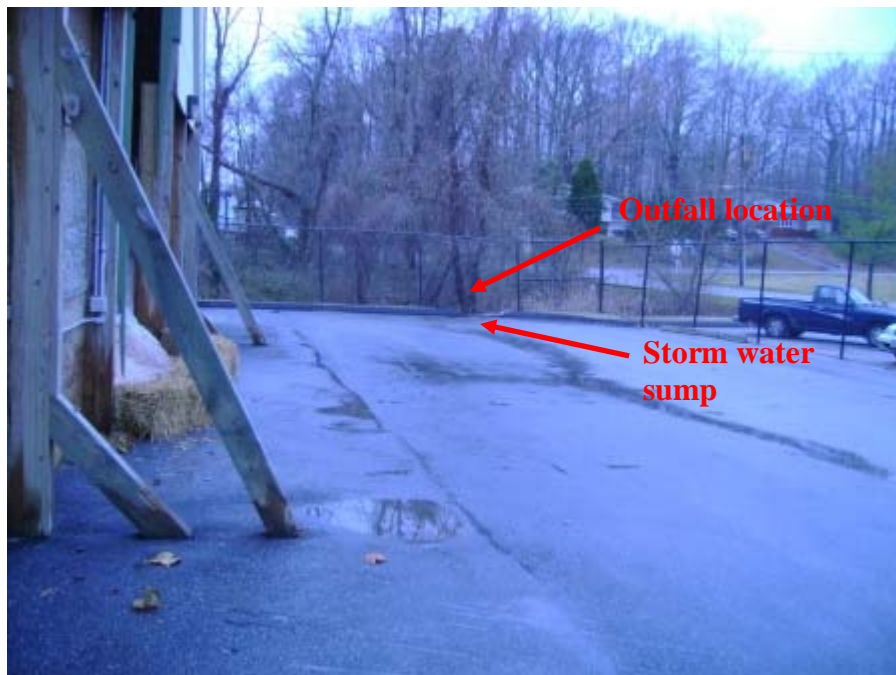
Photograph 44. Central District Roads – Crownsville Yard – County Properties
View of salt loading and unloading area outside of salt barn located on south west corner of the facility. (NOTE: Area drains to sump located in background of the Photograph and can overflow to storm water discharge point)

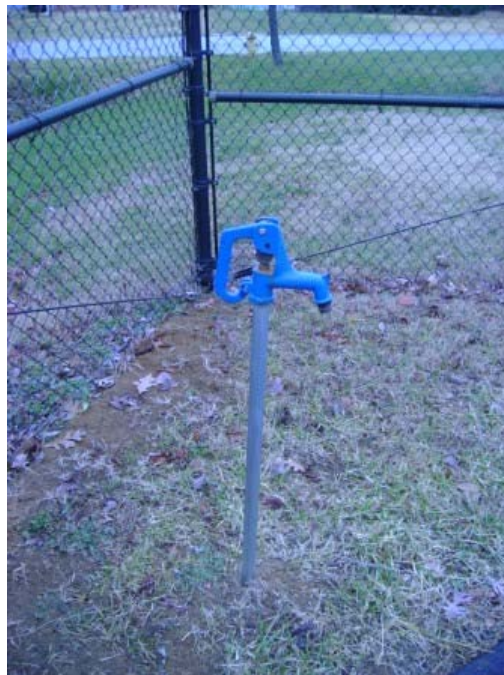
Photograph 46. Central District Roads – Crownsville Yard – County Properties
View of spigot adjacent to storm water sump and storm water discharge location. (NOTE:
Spigot is not locked to prevent vehicle washing or hosing down of salt storage
loading/unloading area)

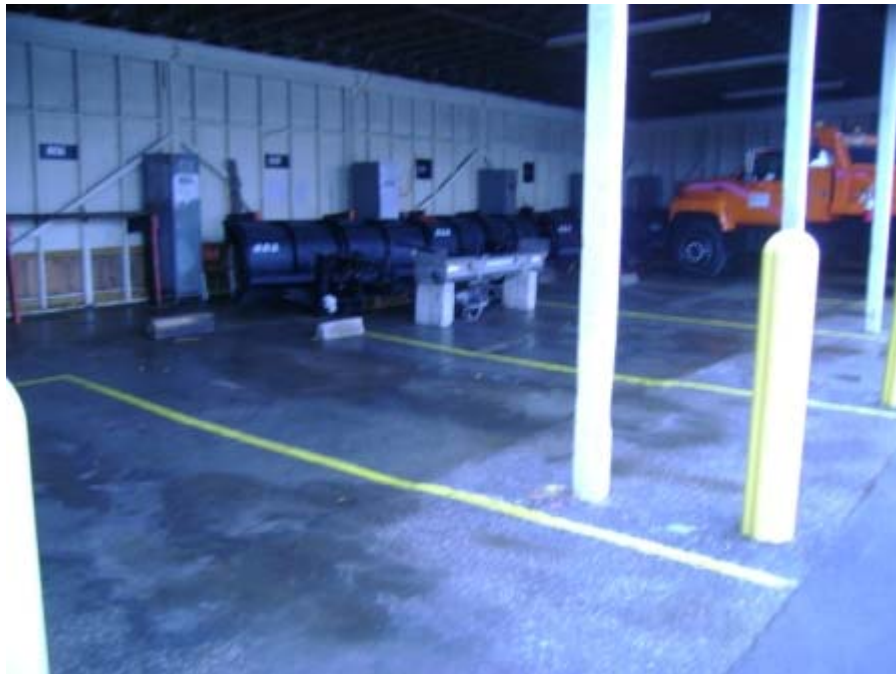
Photograph 50. Central District Roads – Odenton Yard – County Properties
View of covered vehicle/equipment storage area. Storm water was evident throughout covered area due to apparent roof leaks. (NOTE: Staining evident throughout area)

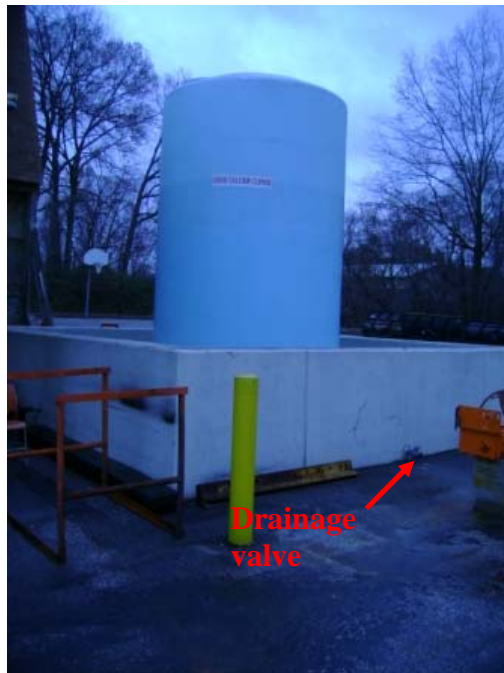
Photograph 52. Central District Roads – Odenton Yard – County Properties
View of 5,500 gallon calcium chloride storage tank with secondary containment. (NOTE: Drainage valve was open when EPA Inspection Team arrived at tank and Facility representative closed it upon notification by the EPA Inspectors)

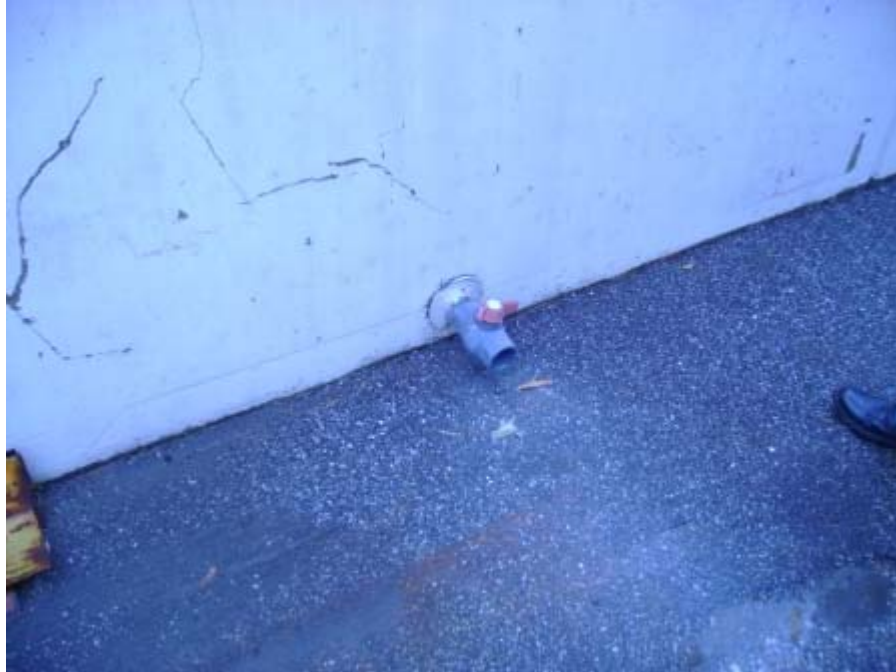
Photograph 53. Central District Roads – Odenton Yard – County Properties
View of secondary containment drainage valve. Facility personnel closed valve upon EPA inspection team notifying them that the valve was in the open position. (NOTE: Staining on ground is apparent near valve)

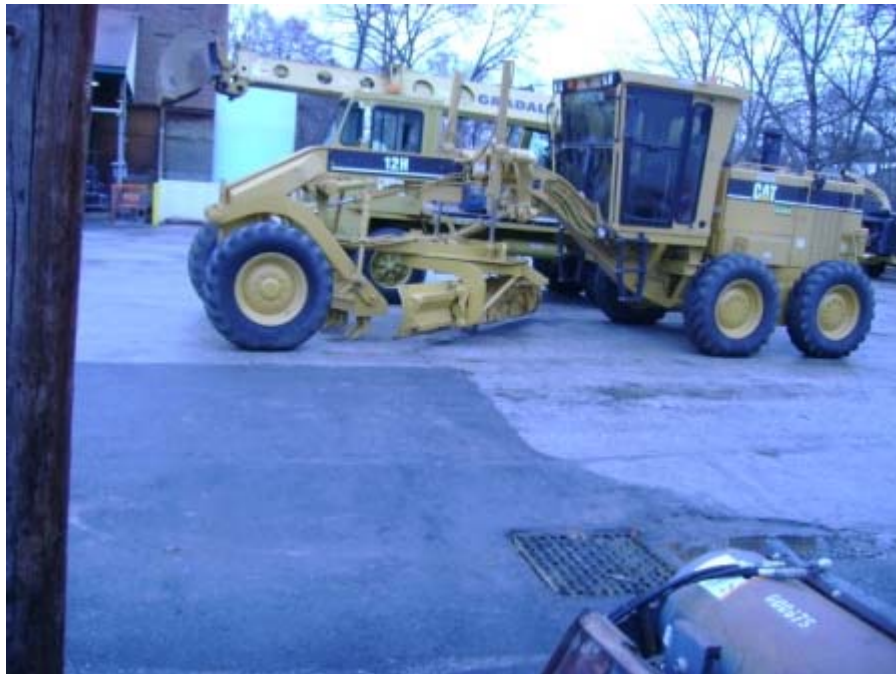
Photograph 54. Central District Roads – Odenton Yard – County Properties
View of uncovered vehicle/equipment storage near storm drain to on-site storm water management pond.

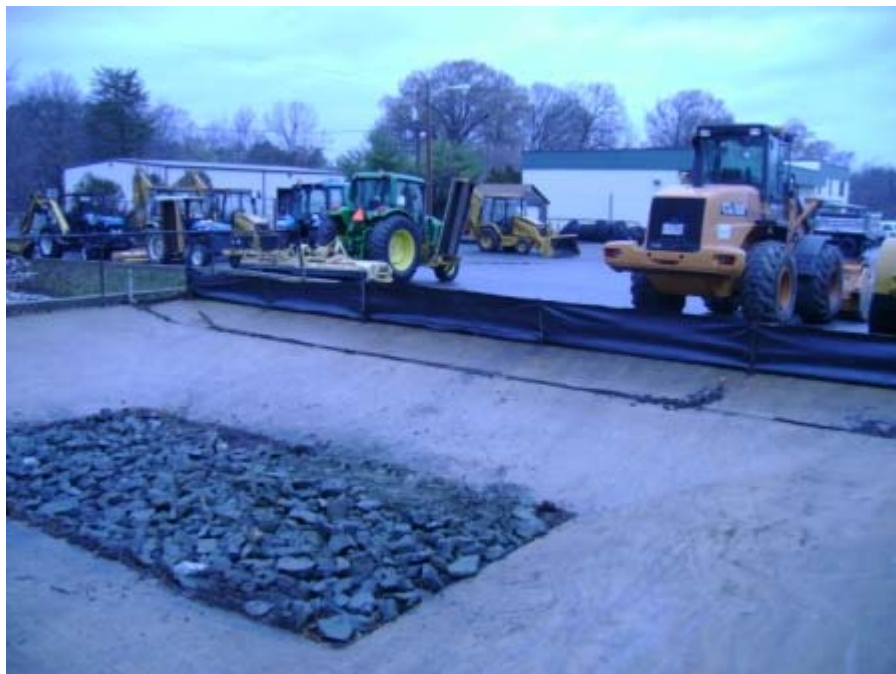
Photograph 56. Central District Roads – Odenton Yard – County Properties
View of trash and debris dewatering gravel pit, leachate drains to storm water management pond.

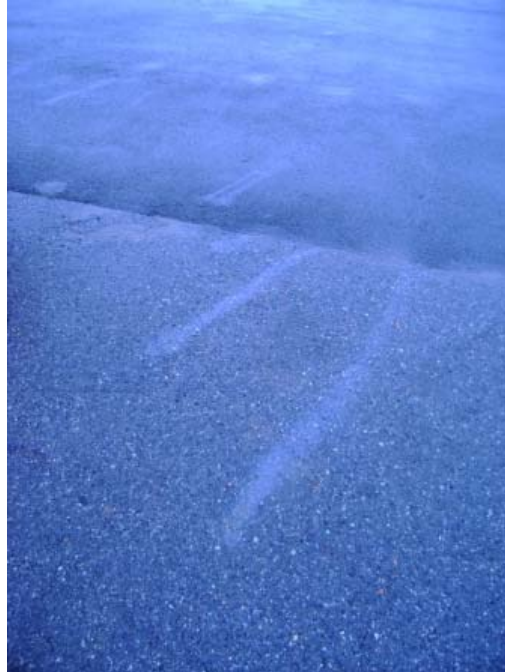
Photograph 63. Central District Roads – Odenton Yard – County Properties
View of sheen on pavement at Facility.
